1.0 INTRODUCTION

In this chapter some case studies of failure are presented. In each case study, the possible learning points, technical aspects and ethical implications are also discussed.

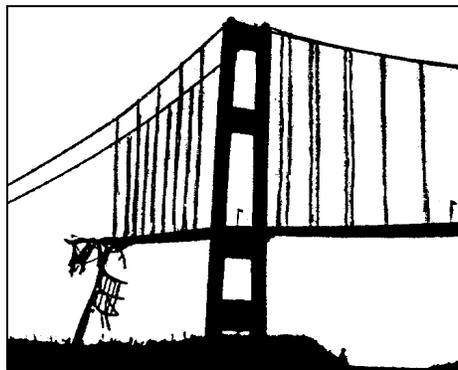
Fig. 1: Tacoma Narrows Bridge

In 1940, Tacoma Narrows Bridge was opened across Tacoma Narrows in Washington State. On Nov 7, 1940, with a wind speed of about 60 km/h (well below the design wind speed), the bridge began twisting and oscillating violently. As a result the tie down cables intended to stiffen the bridge snapped, causing the entire structure to crash into the river below.

Investigations (subsequent to the collapse) showed that the excessive vertical and torsional oscillations (which occurred prior to failure) were the result of extraordinary degree of flexibility of the structure and its relatively small capacity to absorb the dynamic forces. The deck was too narrow for the span and thus its torsional rigidity was inadequate. The plate girders, which were provided for stiffening, had insufficient flexural rigidity and little torsional rigidity. Their elevation caused wind vortices above and below the deck in moderate and steady winds. From the day bridge was opened very substantial horizontal and vertical movements of the deck in waveforms were noticeable even in moderate wind and high traffic.

The failure was indeed caused by a lack of proper understanding of aerodynamic forces and knowledge of torsional rigidity in the whole profession. It was not realised by the designers that the aerodynamic forces (which had proven disastrous in the past to much higher and shorter flexible suspension bridges) would affect a structure of such magnitude as the Tacoma Narrows Bridge, despite the fact that its flexibility was greatly in excess of that of any other long span suspension bridge.

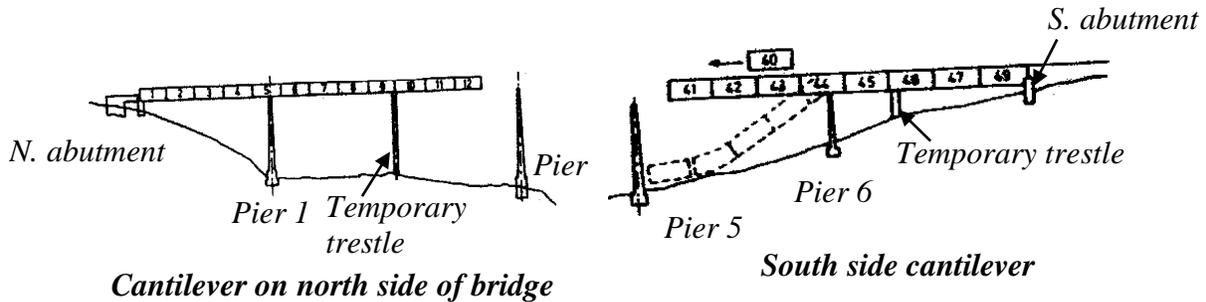
Fig. 2: Failure of Milford Haven Bridge

On 2 June 1970, Cleddau Bridge in Milford Haven failed during its erection by cantilevering segments of the span, out from the piers. The bridge was designed as a single continuous box girder of welded steel. The span that collapsed was the second one on the south side. The boxes were fabricated in sections and moved over the previously built sections, aligned in place and welded. The collapse occurred when the last section of box for the second span was being moved out along the cantilever. This section slid forward down the cantilever buckled, at the support and collapsed into the river (Fig 2), killing four men, including the site-engineer.

Investigation of collapse showed that the collapse was due to the buckling of the diaphragm at the support (i.e., at the root of the second span being erected). The diaphragm was torn away from the sloping web near the bottom. This caused reduction in the lever arm between flanges resisting negative bending moment at the support. The tendency of the bottom flange to buckle was inevitably increased by the reduction of the distance between the flanges, as this increased the force needed in each flange to carry the moment with the reduced lever arm.

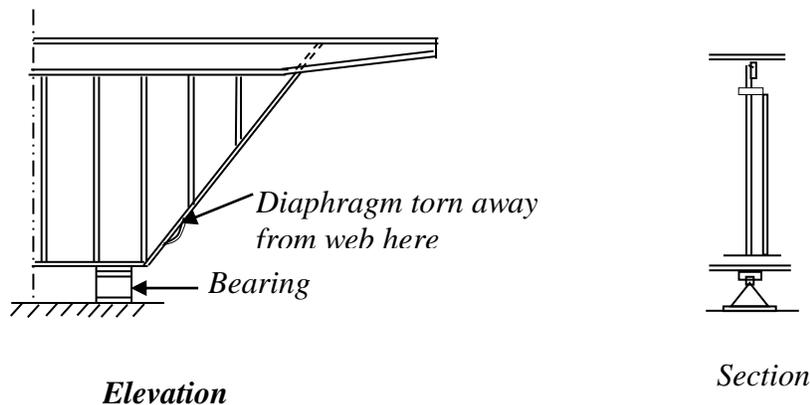
Fig. 3: Diaphragm over Pier 6 of Milford Haven Bridge

The support diaphragm was, in effect, a transverse plate girder, which carried heavy loads from the webs of the plate girder at its extreme ends and was supported by the bearings as shown in Fig 3. It was therefore subjected to a hogging bending moment and a large vertical shear force. The shear of the transverse girder and diffusion of the point load from the bearings were compounded with the effects of inclination of the webs of the main bridge girder. These produced an additional horizontal compression and out-of-plane bending effects caused by bearing eccentricity.

The total load transmitted by the diaphragm to the bearings just before collapse was computed as 9700 kN . This load would not have caused any problem provided the diaphragm was designed to carry it. Allowing for likely values of distortion and residual stress, the calculated design strength, using design rules that were drafted subsequently, was found to be as low as 5000 kN . Thus, the failure was essentially due to design inadequacy.

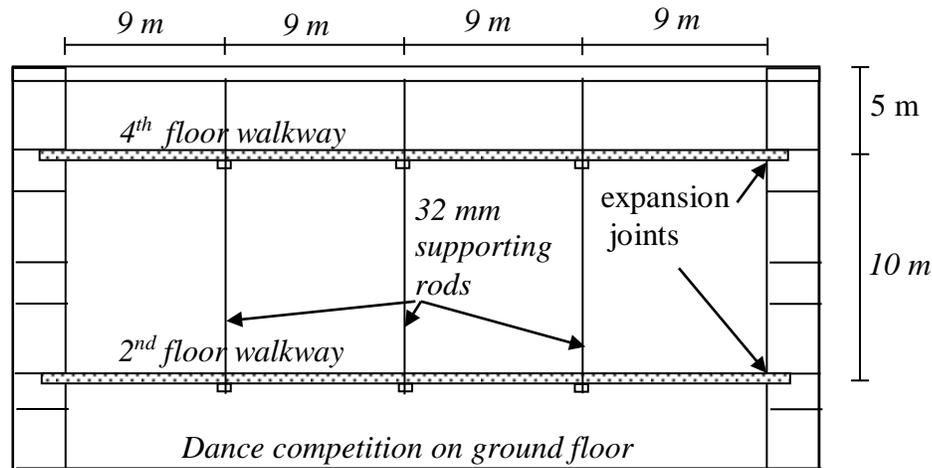
Fig. 4: Kansas City Hyatt Hotel: arrangement of walkways

On 7th July 1981, a dance was being held in the lobby of the Hyatt Regency Hotel, Kansas City. As spectators gathered on suspended walkways above the dance floor, the support gave way and the upper walkway fell on the lower walkway, and the two fell onto the crowded dance floor, killing 114 people and injuring over 200.

The two walkways were supported above one another and suspended from the ceiling by hanger rods as shown in Fig 4. The walkways were supported on box beams, which were made of two steel channels, welded together.

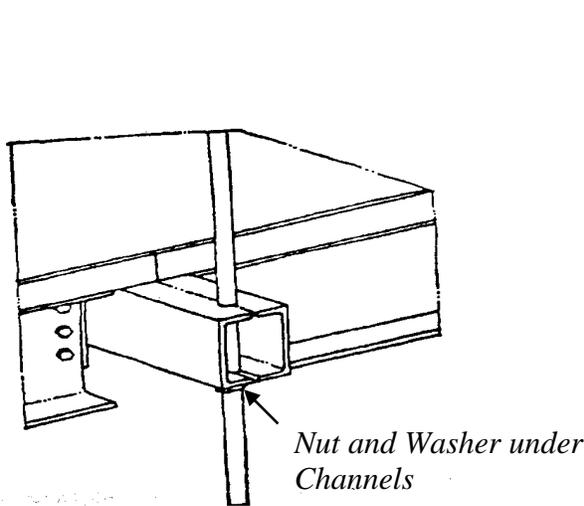
Fig. 5(a): Hyatt Regency Hanger Details As-Designed

In the original design a single rod supported the two walkways as shown in Fig. 5(a). But the originally designed hanger detail for the two walkways was altered at the time of fabrication as shown in Fig. 5(b). The second floor walkway was suspended from the fourth one as shown. As a result, the connection between the fourth floor cross beam and

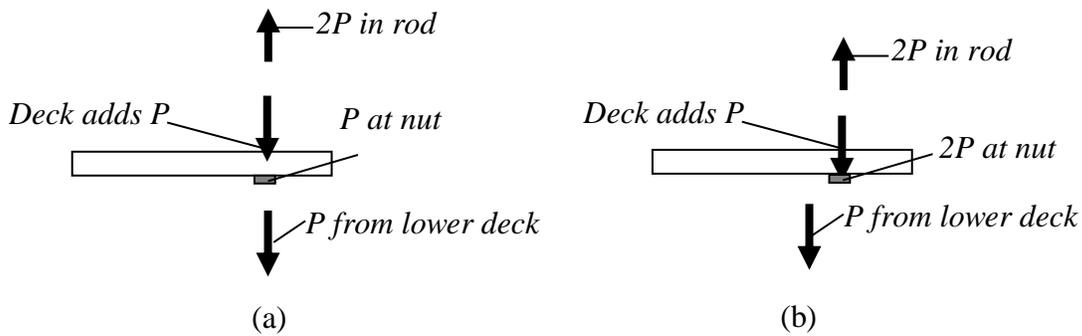
Fig. 6: Free-Body Diagram (a) As Designed (b) As Built

the hanger supported double the load originally intended as shown in Fig 6(b). Examination of the box beams supporting the upper walkway after the collapse showed that the upper hanger rod had pulled through the beam. The beam design was also unsatisfactory, and this condition was aggravated by the increased load on the nut. The nut pulled through the box beam as shown in Fig. 7.

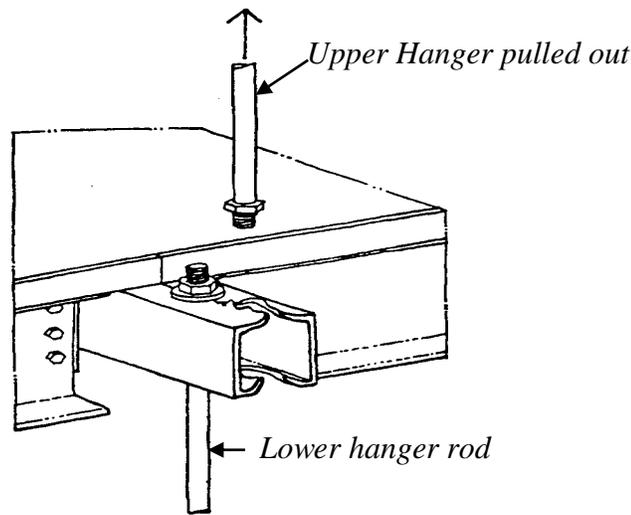
Fig. 7: Pulled -Out Rod at Fourth-Floor Box Beam

After the investigations, it was found that the steel fabricator who built the hanger detail requested a change in detail from the originally designed detail. The engineer approved it without checking the calculations. This accident occurred due to the carelessness of the engineer concerned as he failed to understand the importance of the details he had changed. It also illustrates the importance of understanding the force flow in the joints and that of what is often considered as minor detail.

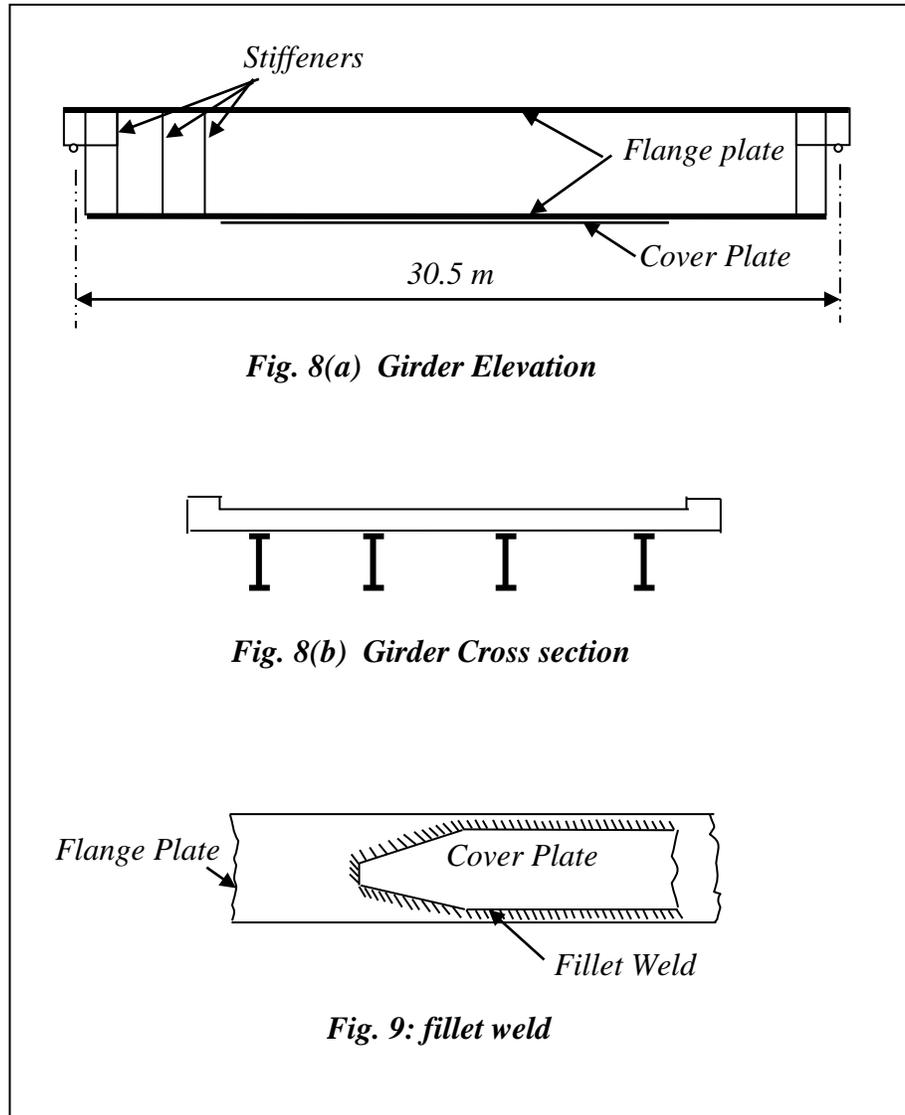
An investigation into the possible cause of failure indicated that the failure was due to brittle fracture and many other spans of the bridge were in danger of similar failure. Cracks were found in the main tension flange plate of the affected span under seven of the eight transverse fillet welds. One crack had extended such that tension flange was completely severed, and the crack had extended halfway up the web.

transverse welds were made in three stages. In some instances cracks were caused in the main flange plate by the first run and later covered up by a subsequent one. In many other cases a crack was caused by the last run and later covered up by priming paint before the girders left the factory. The penetration of later paint coats into the cracks showed that they had often extended further before the bridge was opened for traffic.

The results of investigations clearly indicated that, the failure of King's Bridge was due to carelessness of those who fabricated the girders as well as those who inspected the bridge. It was also found that the most likely and most dangerous cracks were regularly missed by inspectors, who had carefully got the less harmful longitudinal cracks cut out and repaired.

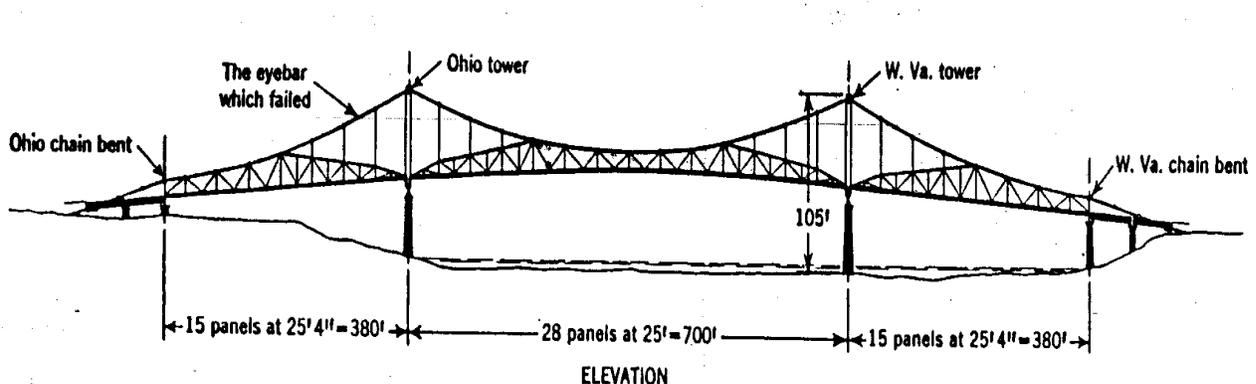
Fig. 10 a: Silver Bridge at Point Pleasant

On Dec 15, 1967 Silver Bridge, considered to be first eyebar suspension bridge in the United States, collapsed without warning into the Ohio River. The bridge was spanning Ohio River between Point Pleasant, West Virginia, and Gallipolis, Ohio. The collapse occurred when the bridge was crowded with heavy traffic resulting in the loss of 46 lives and nine injuries.

A thorough investigation revealed that the collapse of the bridge was caused by the failure of the eyebar at the first panel point west of Ohio tower as shown in Fig. 10.

At the beginning, the first joint of the eyebar, west of the Ohio tower came apart. As a result of the separation of the joint and the failure of the eyebar, the Ohio tower fell eastward. The collapse continued eastward, causing the West Virginia tower to fall eastward. Thus once the continuity of the suspension system was severed at first panel point west of Ohio tower, the unbalanced forces on each side of that joint caused the bridge to totally disintegrate.

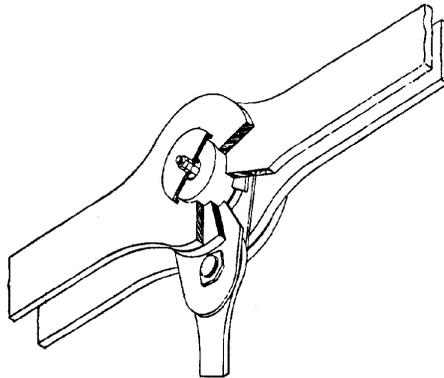
Fig. 10 b: Detail of Eyebar Chain Joint

Investigations showed that there were two main elements in the design and construction of the chain that caused the failure - extremely high tensile stresses and corrosion on the inside of the eyebar.

Another undesirable feature of the design was that the eye, where the pin fits, was elongated 3 mm in a horizontal direction for ease of erection. This detail created an air space where corrosion could develop undetected and unabated. The inspection or lubrication of the inside of the head of the eyebar in the Silver Bridge was impossible without dismantling the joint

Thus the combination of high tensile stresses and corrosion caused a crack on the inside of the eyebar, under the pin at a location of a manufacturing flaw about 6 mm in size.

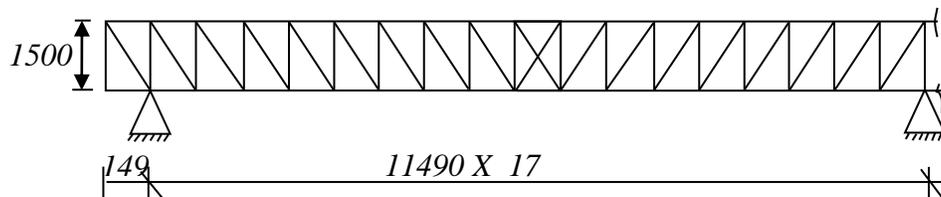
Fig. 11: Elevation of Truss

The case study concerns a factory building near Nellore, India. The building was of size $25.7\text{ m} \times 52.5\text{ m}$. The roof was made up of steel Pratt trusses supported on concrete columns. The entire truss was exposed except for the bottom chord members, which were embedded in concrete slab.

After curing the concrete slab, when the scaffoldings were removed, the deflection of the roof was found to be 100 mm ($>L/325$). In order to find out the cause of these disproportionate deflections, the truss was reanalysed. The configuration of the truss is shown in Fig. 11. From the analysis, it was found that most of the members of the roof truss were not safe. After performing several analyses, it was concluded that in the original design, the designer might have miscalculated the loads. In India, industrial buildings were normally covered by asbestos cement sheetings. Hence the original designer of the truss, due to his inexperience, might have considered the truss to support Asbestos sheeting, instead of heavier concrete slab. The analysis considering only AC sheet roofing confirmed that all the members of the roof would be safe for the reduced loading.

building. Hence the repair of the roof had to be done without affecting the work of installing these machineries. Hence it was decided to strengthen the top and bottom flanges of the top chord members by welding extra plates on them. It was also decided to weld angles inside the web members of the truss. Since the bottom chord member was inside the concrete slab, it was not possible to add anything to the bottom chords.

It was also recommended to provide temporary supports to the truss at $1/3$ point for welding extra plates and angles. But the contractor did not provide the temporary supports and welded the extra plates and angles. This resulted in the buckling of the web of the top chord members. The web members in one or two trusses had also buckled. Hence after careful consideration it was decided to reduce the span of the truss which would eventually reduce the forces in the members. After consultation with the manager of the plant, the locations of these intermediate columns were fixed and then the work was carried out.

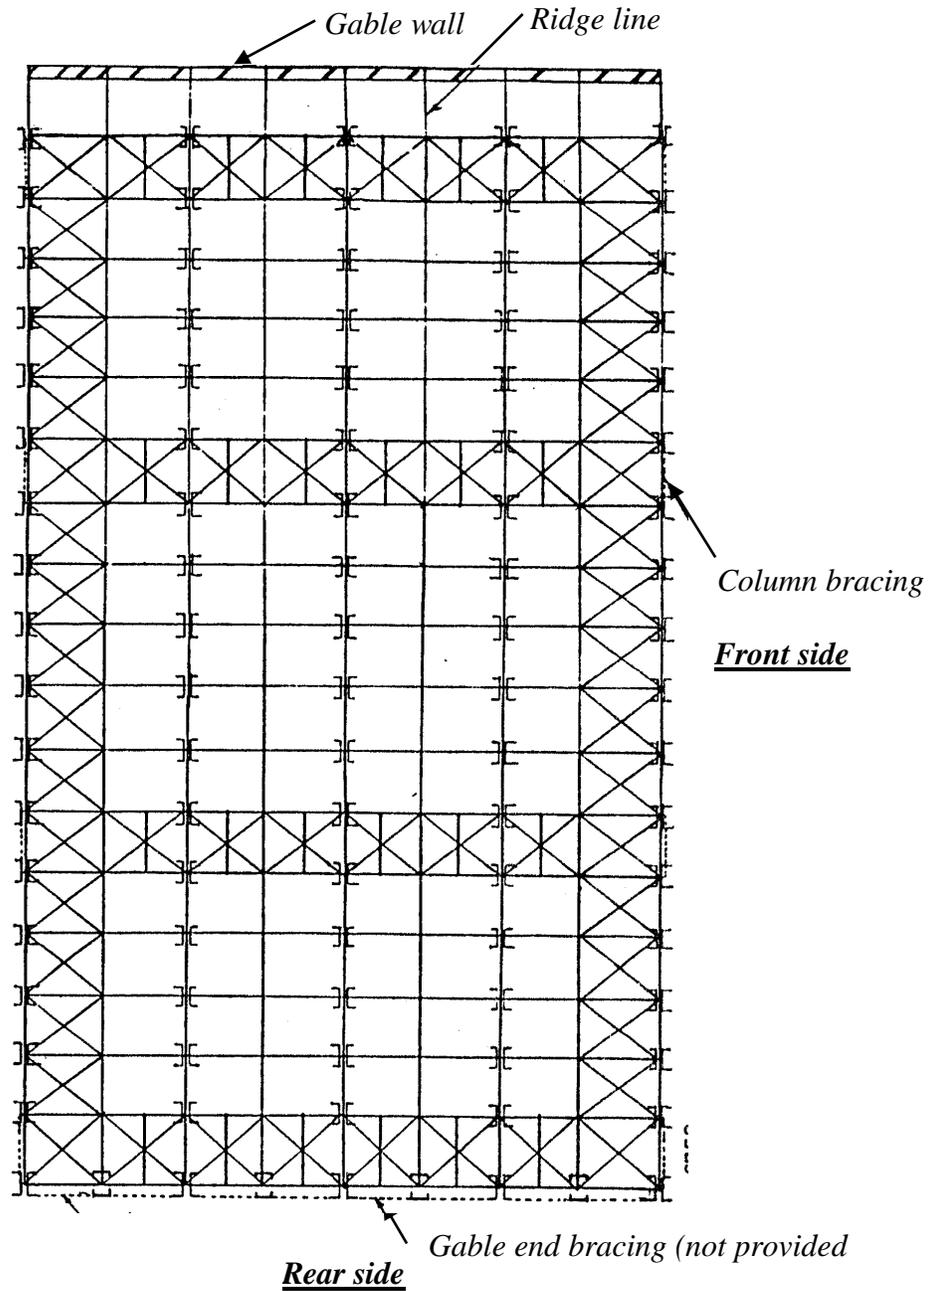
Fig. 12: Layout plan of the factory building

In order to understand the failure of the structure, the original design was examined. The main causes of failure were found to be,

- (i) wind loads were not estimated properly as per IS:875.
- (ii) column and rafter sections were found to be inadequate to resist the load; they did not even satisfy the main ℓ/r ratio specified in the Code.
- (iii) during erection, the bracings were not connected properly to the main members.

For the restoration of the structure, the designer was asked to use the same sections and produce a design, which would not increase the cost of the project considerably. Hence same channels were used; but their spacing was altered to form a box section with diagonal bracings of channel section. The span and bay width were kept the same. This arrangement increased the moment of inertia of the section along the frame and perpendicular to the frame. The rigidity of the structure increased considerably in both

the directions and the bending stress was found to be well within the allowable range of stresses.

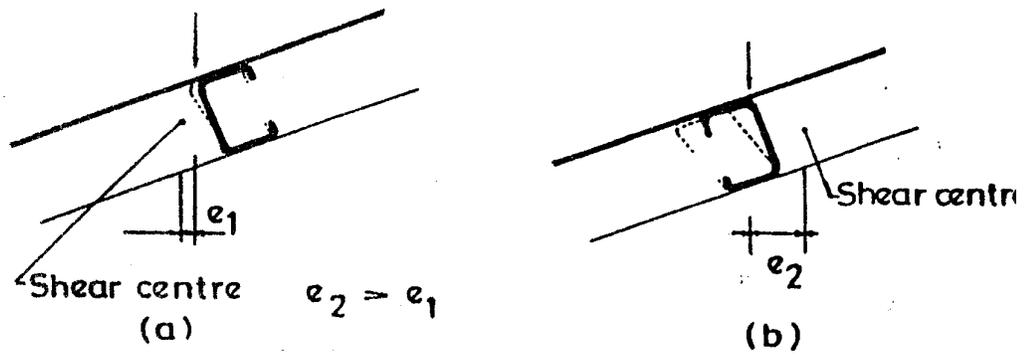
Fig. 15: Torsion of purlins

After the erection of portal frames and placing of asbestos sheets, some problems were encountered. The purlins and side cladding girts got twisted. This resulted in the cracking of some AC sheets. Some columns (especially those supporting the partitions) were not straight and gave a buckled column appearance. Most of the side cladding girts were sagging.
