1.0 INTRODUCTION

In this chapter some case studies of failure are presented. In each case study, the possible learning points, technical aspects and ethical implications are also discussed.

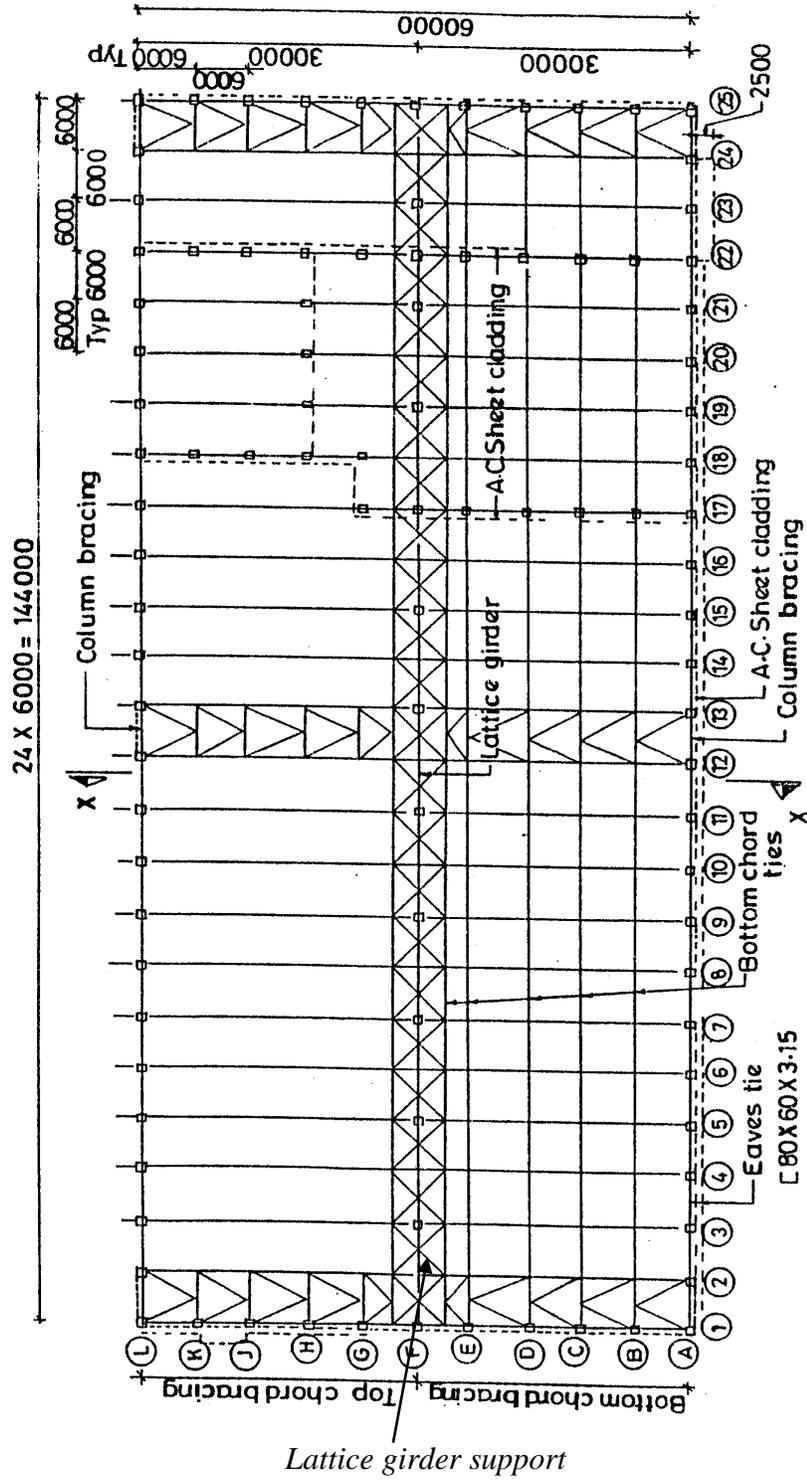
Fig.14: Plan view of the structure

A $144\text{ m} \times 60\text{ m}$ factory building was constructed at Cochin, India. The plan is shown in Fig.14. The building was made up of portal frames spanning 60 m and placed at 6 m intervals. The portal frames were supported alternately on columns and on lattice girder that was placed longitudinally at the mid-span. The portals and columns were made up of four angles, which were laced to form a box section. The lattice girder and the central column were made up of 4 channels, laced to form a compound section. The sides of the building were also covered by cladding from 1.5 m above G.L.

After the erection of portal frames and placing of asbestos sheets, some problems were encountered. The purlins and side cladding girts got twisted. This resulted in the cracking of some AC sheets. Some columns (especially those supporting the partitions) were not straight and gave a buckled column appearance. Most of the side cladding girts were sagging.

The sagging of the side cladding girts was due to the fact that the sag rods were not anchored by providing diagonal sag rods at the ends. This was rectified. The other problem was due to the fact that the fabricator was not experienced in cold rolled steel sections. Since these sections were flexible and made of thin sections, the fabricators simply bent the columns and fixed them at the required place. These mistakes were also rectified. However, these corrective measures delayed the starting of the plant production by about six months.

By this time all the machinery of the plant had arrived and the erection of these was in progress. It was also a costly proposition to remove all the AC sheets, correct the detailing errors by refabricating the joints and relaying the AC sheets. Hence after several rounds of discussions, it was decided to replace only the cracked AC sheets and to adopt a temporary solution as shown in Fig.17 which would arrest further twisting of the purlin.
